# Evaluating Accident Models using Recent Aerospace Accidents<sup>12</sup>

## *Part I: Event-Based Models*

Nancy Leveson

June 28, 2001

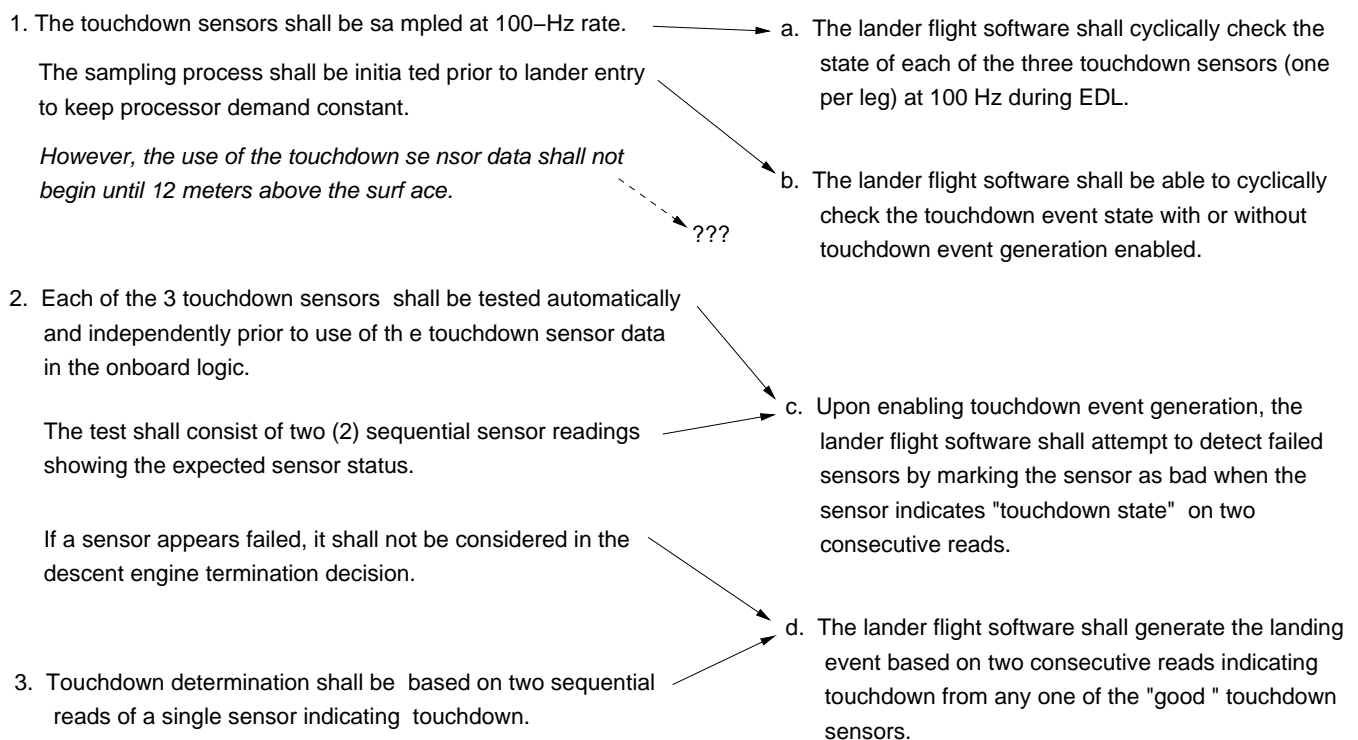
Figure 3.2: The Mapping of MPL System Requirements to Software Requirements

told, he or she may have thought that the problem was solved by the requirement not to use the touchdown sensor data until the 40-meter altitude had been reached. By that time, the transient would no longer be present<sup>8</sup>.

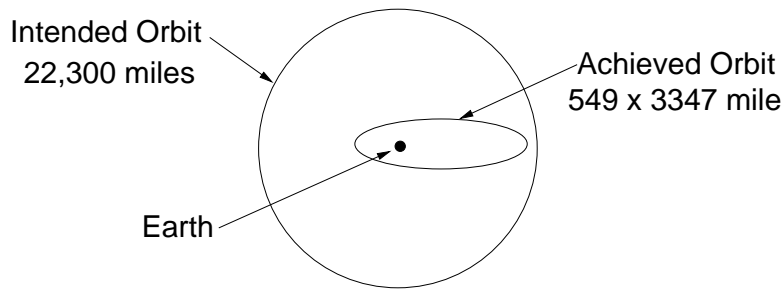
Figure 3.3: Achieved Orbit vs. Intended Orbit

- E11** The vehicle's third burn started at T+02:34:15. It tumbled throughout the third burn, which started earlier and was shorter than programmed.
- E12** Space vehicle separation occurred at approximately T+02:54:15, but the Milstar satellite was placed in a useless low elliptical final orbit, as opposed to the desired geosynchronous orbit (Figure 3.3).
